Maryland Inventory of Historic Properties Number: AL-V-A-314

Name: WID 36 over Jennings Run (1008)

MARYLAND INVENTORY OF HISTORIC BRIDGES
HISTORIC BRIDGE INVENTORY
MARYLAND STATE HIGHWAY ADMINISTRATION/
MARYLAND HISTORICAL TRUST

SHA Bridge No. 1008 Bridge name MD 36 over Jennings Run

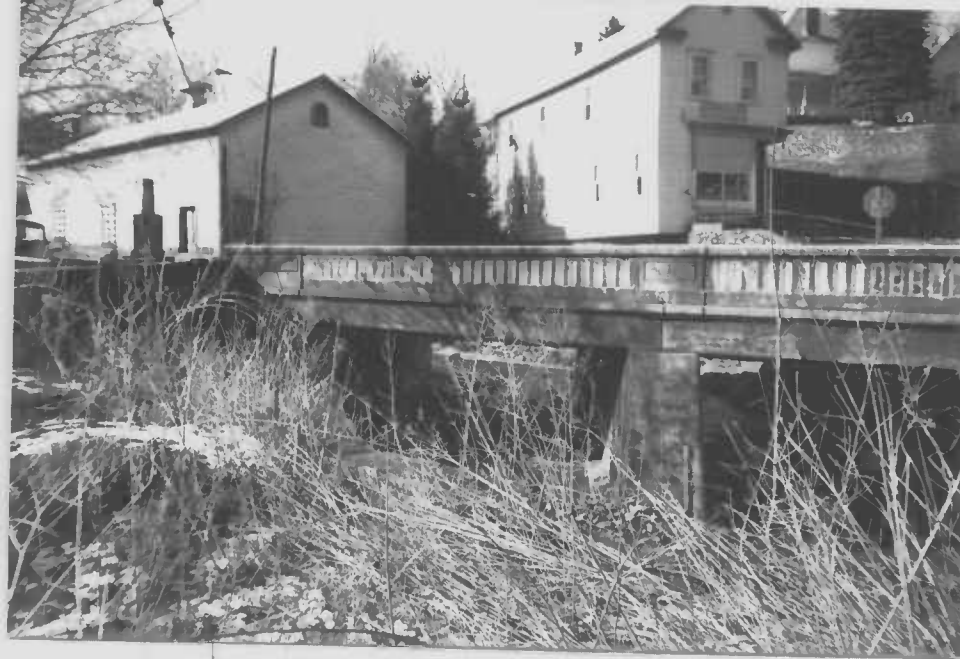
1. AL - V - A - 314
2. MD 36 over Jennings Run
3. Allegany Co, MD
4. Ryan McKay
5. 3/97
6. MD SHPO
7. Downstream elevation - south span
8. 1 of 6

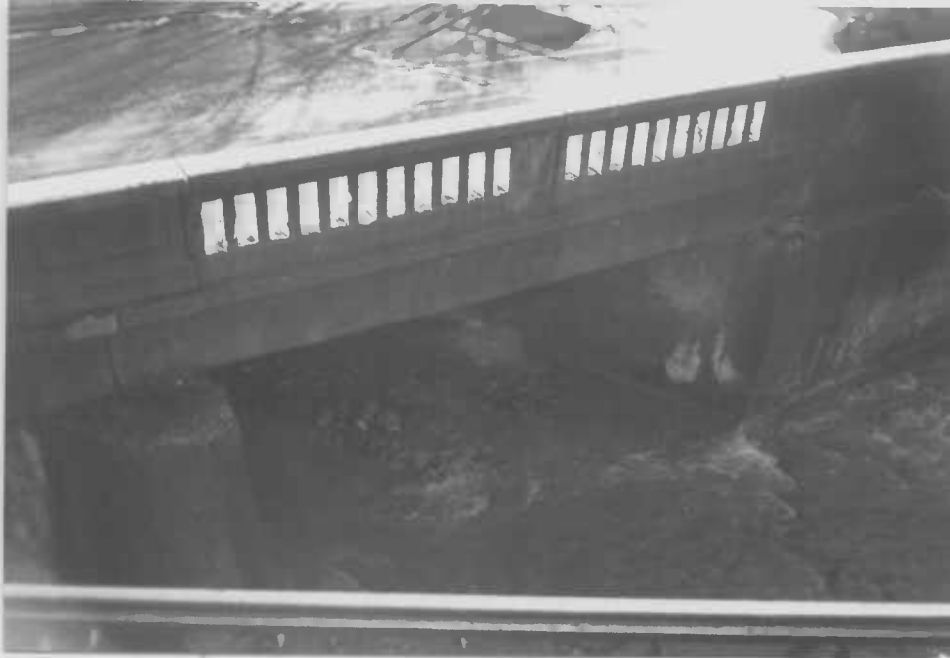
1. AL-V-P-314
2. MD 36 Over Jennings Run
3. Allegany Co, MD
4. Ryan McKay
5. 3/97
6. MD SHPO
7. Upstream elevation - South Span
8. 2 of 6

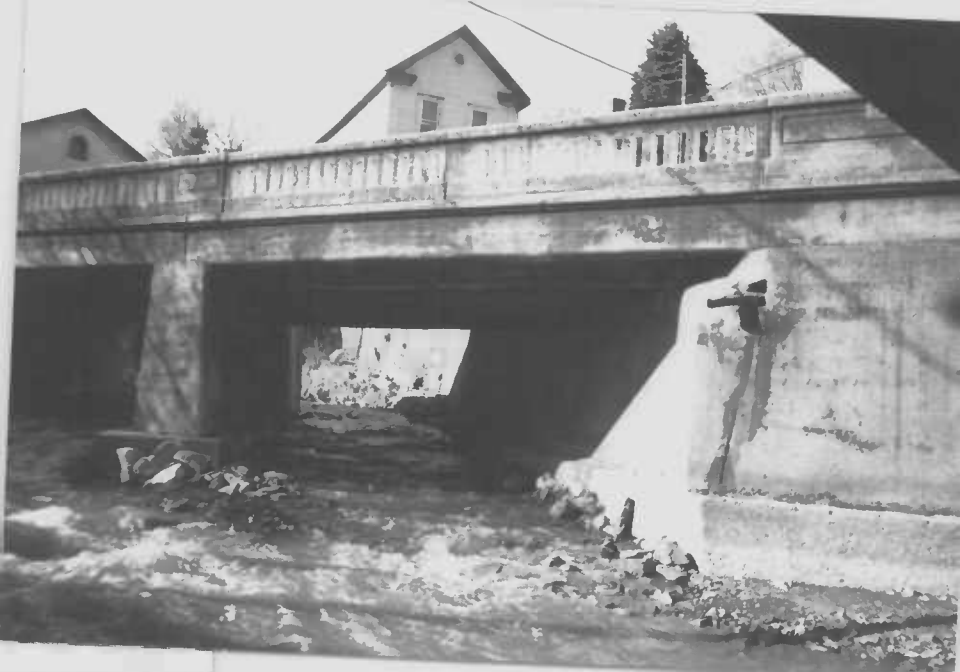
According to the 1997 inspection report, this structure is in fair condition with some scour at the abutments and piers. During the field survey conducted by P.A.C. Spero & Company, it was noted that the concrete substructure and superstructure have areas of cracking, scaling, and spalling. The concrete beams have areas of scaling, spalling, and rusting. The asphalt wearing surface has depressions in the traffic lanes. Also, the concrete parapets are in good condition, with some areas of spalling. The parapets have been painted, and there are areas of chipped and flaking paint.

1. ALV-A 314
2. MD 36 over Jennings Run
3. Allegany Co, MD
4. Ryan McKay
5. 3/97
6. MD SHPO
7. Detail of beam
8. 3 of 6

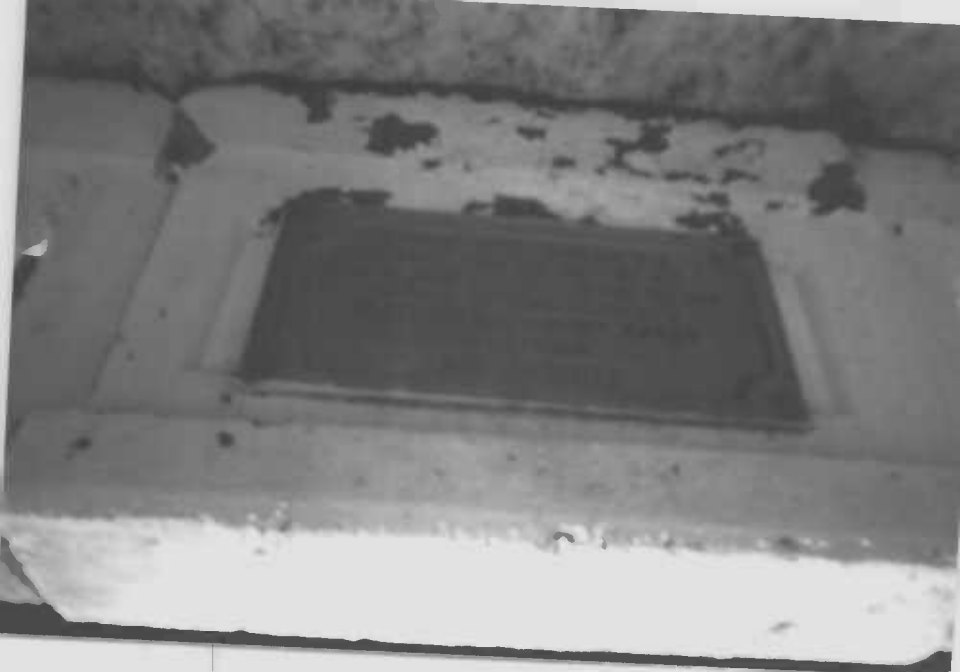
8. 4 of 6

7. Detail of plaque

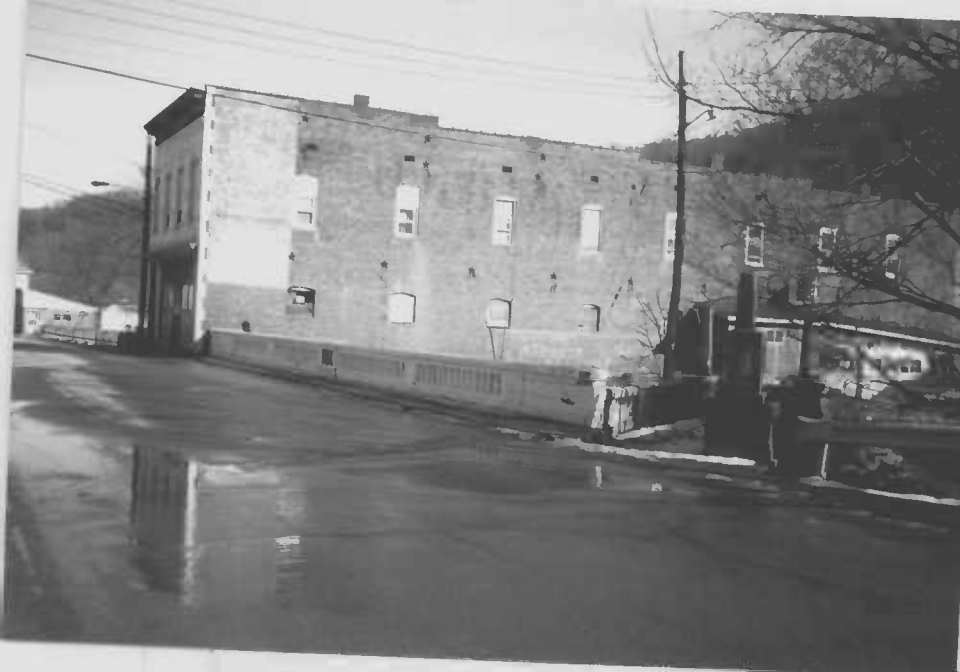
8 5 of 6

7 east parapet

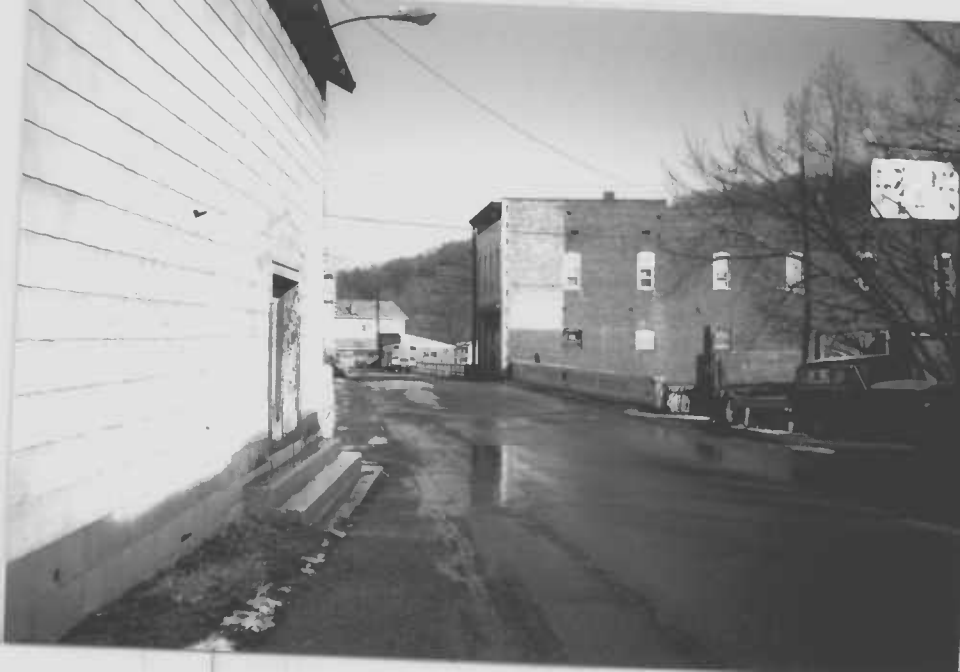
- 1 AL-V-2-314
- 2 MD 36 over Jennings Run
- 3 Allegany Co. MD
- 4 Ryan McKay
- 5 3/97
- 6 MD SHAPO
7. South approach
8. 6 of 6
